# Using Infrared Technology – for Optimal Property Management

October 2005

Paul Daniele and Christopher Daniele

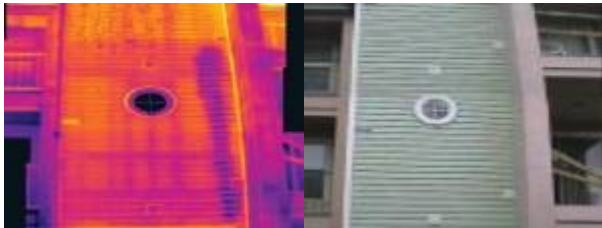
The thermogram of this vinyl-sided 3-floor apartment house clearly shows the path of a serious leak from a washing machine on the third floor, which is completely hidden within the wall. The thermographer used FLIR's Image Builder software to automatically "stitch" the three individual thermographs into one fully thermographic collage.

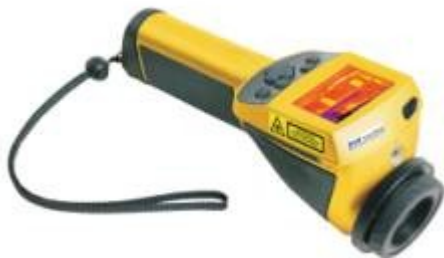
The B2 Building Diagnostics Infrared Camera from FLIR Systems

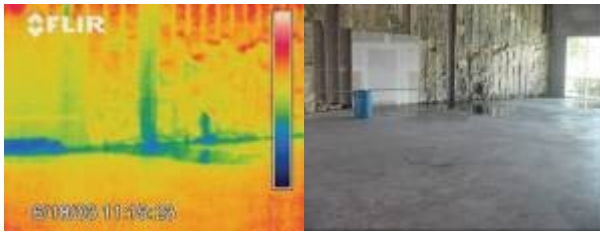
The thermogram on the left shows water and moisture remaining from sprinklers that were activated during a fire that was knocked down about 11 hours earlier. Note how the IR thermography clearly identifies the wet areas in the insulation and building structure and on the floor by their relatively cooler temperatures.

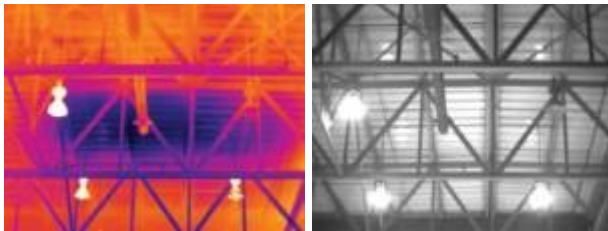
Interior infrared survey conducted during daytime hours reveals central area of roof saturated with moisture and in need of immediate repair.

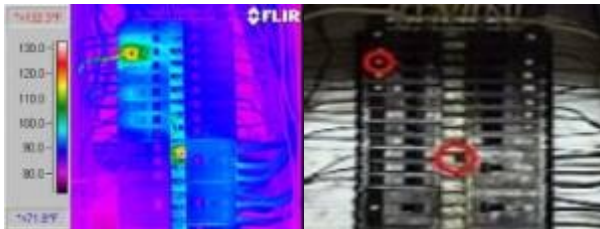
Note how thermography easily finds the problems in this circuit breaker panel.

When a problem calls for a building inspection to take place, an infrared camera is the most accurate tool to address the issue at hand. Infrared thermography can be used for inspection of electrical fuses and circuit breaker boxes, checking them for loose or corroded connections. Any time a circuit is running abnormally hot; it is using extra electricity and therefore costing more money. Plus, an overloaded or malfunctioning circuit is a potential fire hazard. By determining the exact location of a hot spot in electrical wiring, immediate corrective action can be undertaken, thereby saving money and preventing a fire.

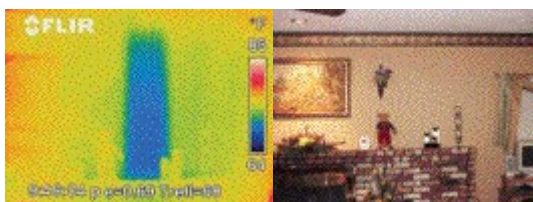
*The occupant complained about a cold spot in this living room in a home that was insulated by a blow-in process from outside. The thermogram at right clearly identifies the source of the cold air as an un-insulated stud bay. By insulating the empty bay, the occupant can save significant costs in heating energy.*

Thermography is the best tool for energy auditing to improve a building or home's thermal efficiency. Older structures are especially vulnerable to heat and cooling loss through walls, ceilings, attics and roofs that lack proper insulation. One of the most common problems is blown insulation that does not fill the entire cavity, or strips of insulation that were not seated properly between two studs. IR imagery clearly reveals any heat or cooling loss issues – so corrective action may be taken.

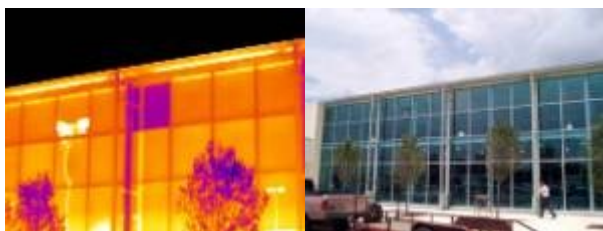
Thermal image of double pane window versus single pane windows – clearly showing the difference in energy efficiency.

Other areas to examine for energy loss include windows, which is a widespread problem for even newer buildings and homes. As a structure settles, stress on the windows and doorframes can cause warping, which in turn causes the seals to leak. These small leaks can multiply, causing a heating or cooling system to run continuously. Infrared imaging can immediately identify these energy leaks so the problem area can be sealed, saving energy and money.
